## Prevent Gas Accidents - Case Analysis

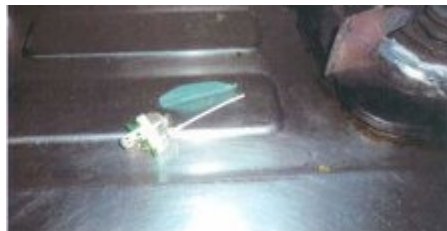
The plastic shell of the lighter cracks under the heat of the stove. LPG leaking out and is ignited by the flame of the stove, causing the minor explosion.

The lighter involved in the incident

Keep lighters away from flame or any environment with a temperature higher than 50°C, such as near an electrical appliance that gives off heat or a cooking stove. Lighters should be stored in a dry, cool, well-ventilated place which is inaccessible to children. Never leave lighters in a car.

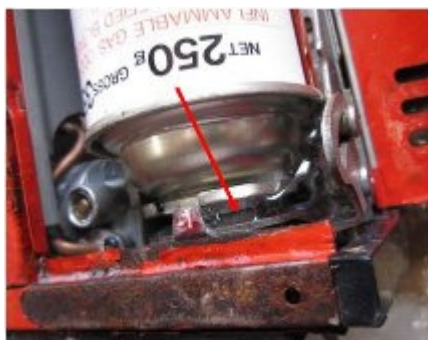
Investigation found that the cassette cooker involved in the incident was purchased more than 10 years ago. It has no flame failure device and has not been properly maintained. The ageing rubber seal ring at the connection between cartridge nozzle and cooker is the cause of the gas leak. A flashover occurred when the male householder tried to switch on the gas-leaking cassette cooker.

Position of gas leak

Purchase cassette cooker bearing the **GU mark** and follow the instructions on the LPG cartridge in handling and changing cartridges. Do not use non-approved accessories.

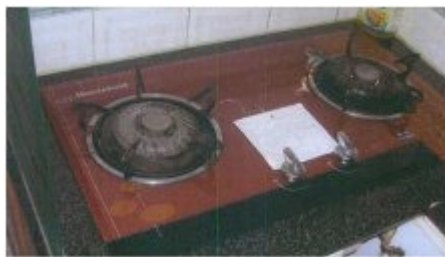
The LPG cooking stove involved in the incident is a non-approved gas appliance (without the GU mark). Although fitted with a flame failure device, that device could not function normally. As the burner on the left is neither switched off completely nor ignited, it results in the LPG leak.

The non-approved gas appliance involved in the incident

Purchase gas appliances that bear the **GU mark**. Arrange for a registered gas contractor to conduct safety checks on the appliance once every 18 months to ensure best performance of the appliance. Check if the switch of the gas appliance is turned off properly after cooking or cleaning.

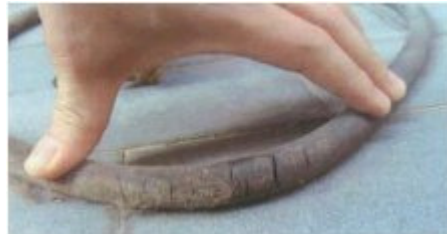
The flexible tubing and regulator of the LPG cylinder have already reached the end of their service life, and there are a number of surface cracks on the flexible tubing. This is the cause of the incident.

A number of cracks are found on the flexible gas tubing

Use flexible gas tubing that is approved by EMSD. Arrange for a registered gas contractor to conduct safety checks on gas installations every 18 months. Change the regulator and flexible tubing before the expiry of service life according to the instructions of the registered gas contractor.

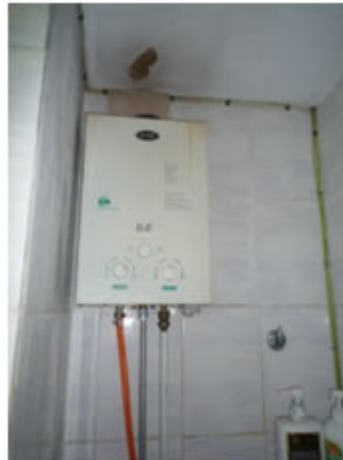
**Cause** The flueless gas water heater used by the deceased is not approved by EMSD. The bathroom was filled with carbon monoxide discharged by the water heater, and the ventilation fan was not turned on when the deceased was taking the shower. That is how the incident happens.

Non-EMSD approved and flueless gas water heater

**Prevention  
Tips** Do not purchase or use gas water heaters that are not approved by EMSD.

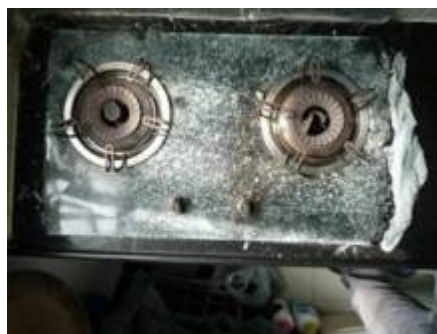
Very often the flame distributor was not cleaned after spillage of food and liquid during cooking, leading to blockage of gas passage, resulting in the flame not being able to burn externally and returning partially to the bottom of the glass panel. The glass panel, having been burned by the back fire for a sustained period of time, would be damaged, and the resulting bulge would shrink when the flame was extinguished, eventually leading to the breaking of the glass panel.

Broken glass panel of built-in gas hob

Clean the burner assembly frequently to maintain a clear gas passage on the flame distributor. Clean and tidy up the flame distributor as soon as possible after spillage of food and liquid. Otherwise, there would be a chance of blockage of gas passage on the flame distributor, resulting in gas not being properly conveyed outside the flame distributor, thus causing back fire and abnormal build-up of heat at the bottom of the glass panel, causing the bursting of the glass panel.
